Case History STABILITY ASSESSMENT

Slope Stability Assessment for Inter-River Park (formerly Premier Street Landfill)

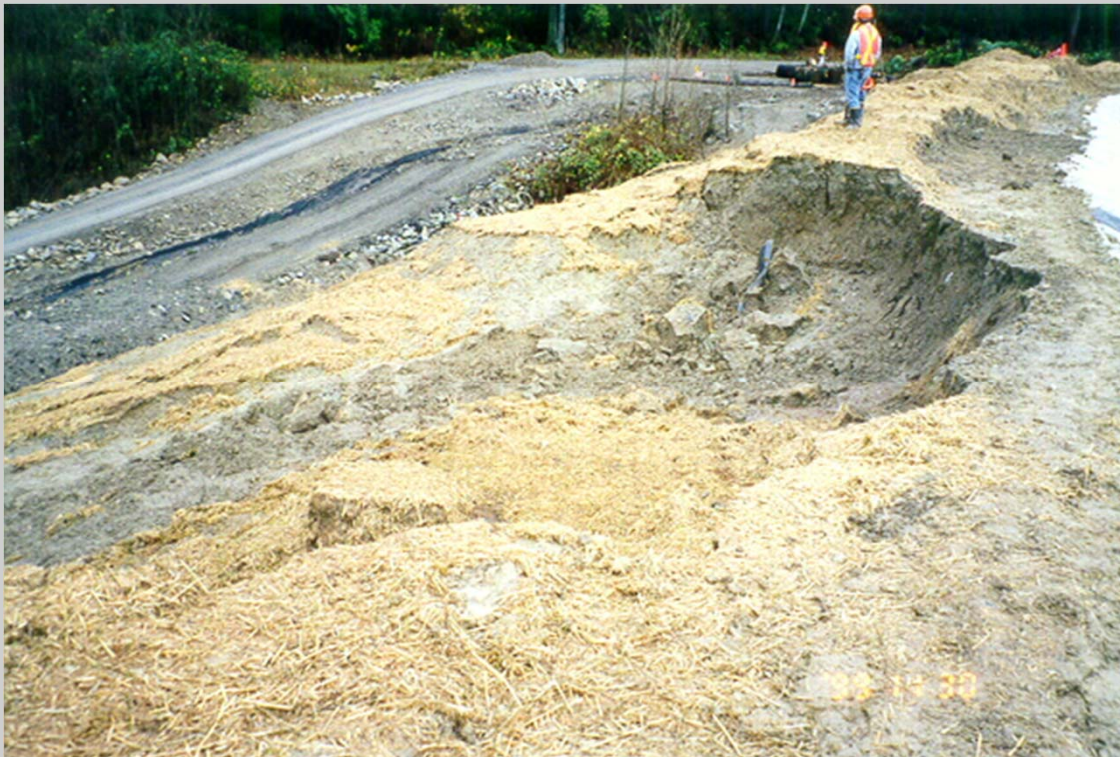
A slump occurred along the north face of the landfill.

- *SHA analyzed slope stability with SG SLOPE software to back calculate strength parameters and to develop a more stable slope design.*
- *SHA designed toe berm and cover system with internal drainage that will minimize risk of future failure.*
- *Slope was successfully restored.*
