Case History STABILITY ASSESSMENT

Geotechnical Services for Slope Stability Assessment of Hope Landfill.

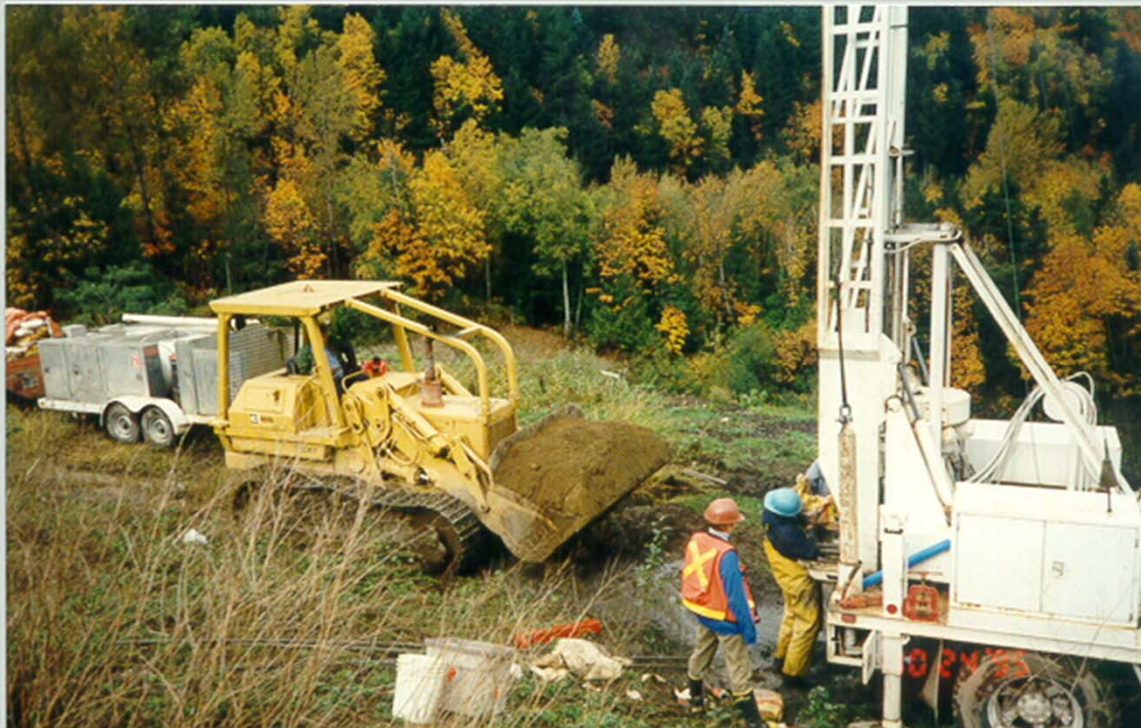
- *MoELP was concerned about 40 m high north face of Hope Landfill that had been constructed with slopes steeper than 2H:1V.*
- *Geotechnical consultants surveyed and identified movement of several cm per year.*
- *SHA installed inclinometers and interpreted survey data.*
- *Data showed that slope is stable. Movement is natural vertical settlement with no down-slope horizontal component.*
