LANDFILL CLOSURE IMPLEMENTATION

South Face Closure – Nanaimo Regional Landfill.

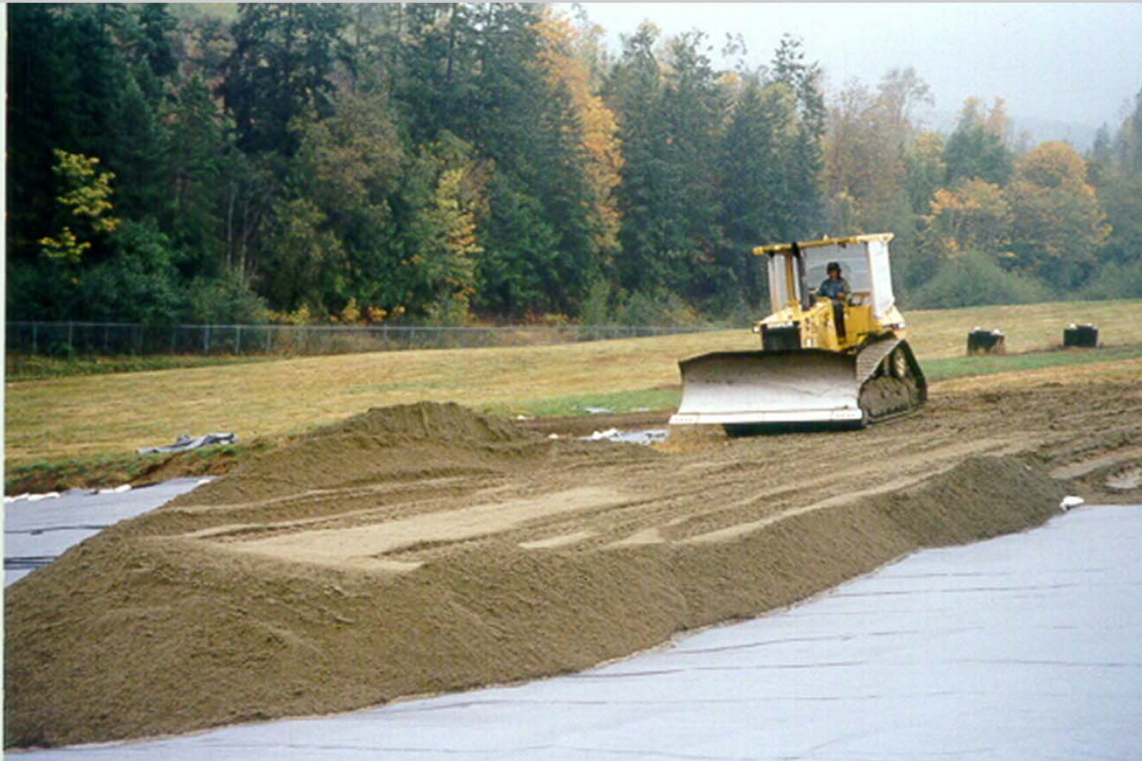
- *SHA designed PVC final cover system for a portion of the South Face.*
- *Top soil was mixed on-site using local compost and sand.*
- *A leachate collector and armoured ditch were installed at the toe.*
- *Landfill gas was contained beneath the membrane and conveyed to a collection trench at the crest of the system.*
- *Closure was completed over 0.81 ha area over 2 months in 2001.*
- *Total cost of closure was \$300,000.*
- *SHA provided design, tender documents and project management services.*
