Case History Design and Construction

West Face Closure Design and Construction – Hartland Landfill (Victoria)

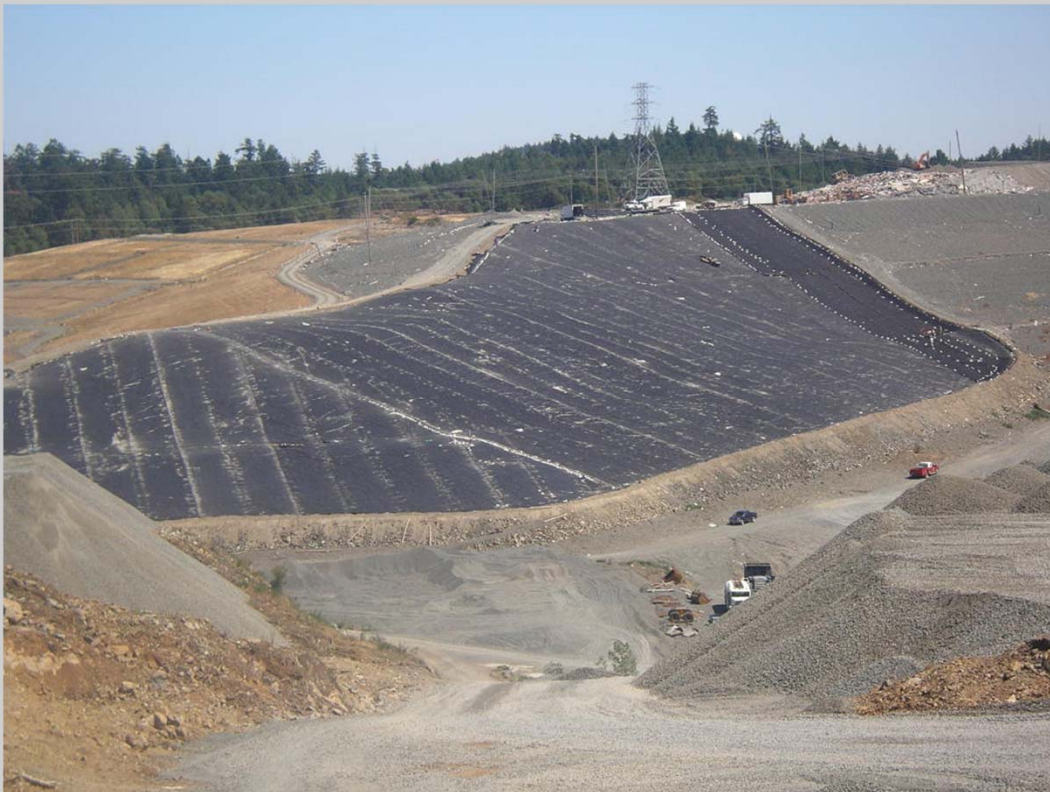
- *Sperling Hansen Associates proposed completing the closure of a 30,000 m² area to minimize air intrusion into the gas collection system and reduce the leachate mound within the landfill.*
- *Waste will be placed on the closure area, any future leachate will be contained and removed from the footprint to minimize leachate mounding.*
- *Lateral landfill gas collection pipes were installed behind the closure / liner system.*
- *A multi-functional surface water collection ditch and leachate collector were installed at the toe of the closure / liner system.*
