LEACHATE COLLECTOR CONSTRUCTION

Leachate Seep Collector Construction Hugo Ray Landfill – West Vancouver

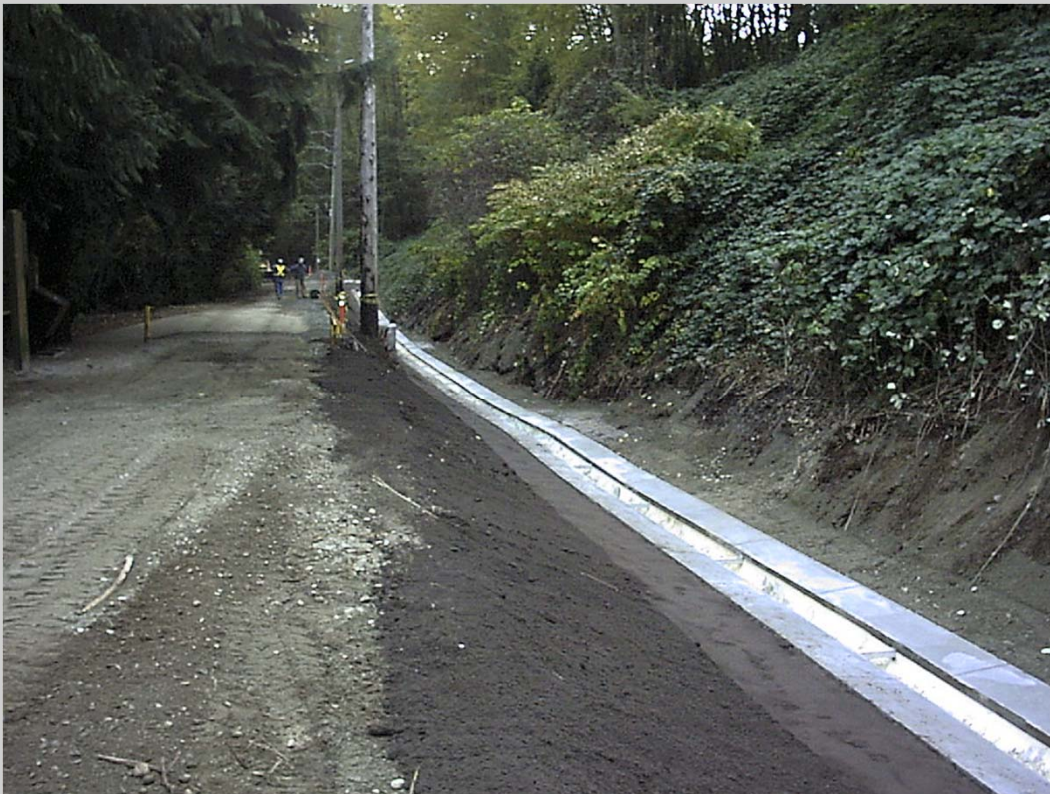
- *SHA prepared the detailed design for a PVC leachate collection ditch, inlet/overflow structure and monitoring flume to clean up the appearance of the ditch and properly collect leachate.*
- *The design consisted of a PVC half-pipe ditch at the toe of the slope, a concrete inlet, outlet and overflow structure and a flume for monitoring flow.*
