### LANDFILL GROUT DESIGN/CONSTRUCTION

#### Grout Barrier System Design Premier St. Landfill – North Vancouver

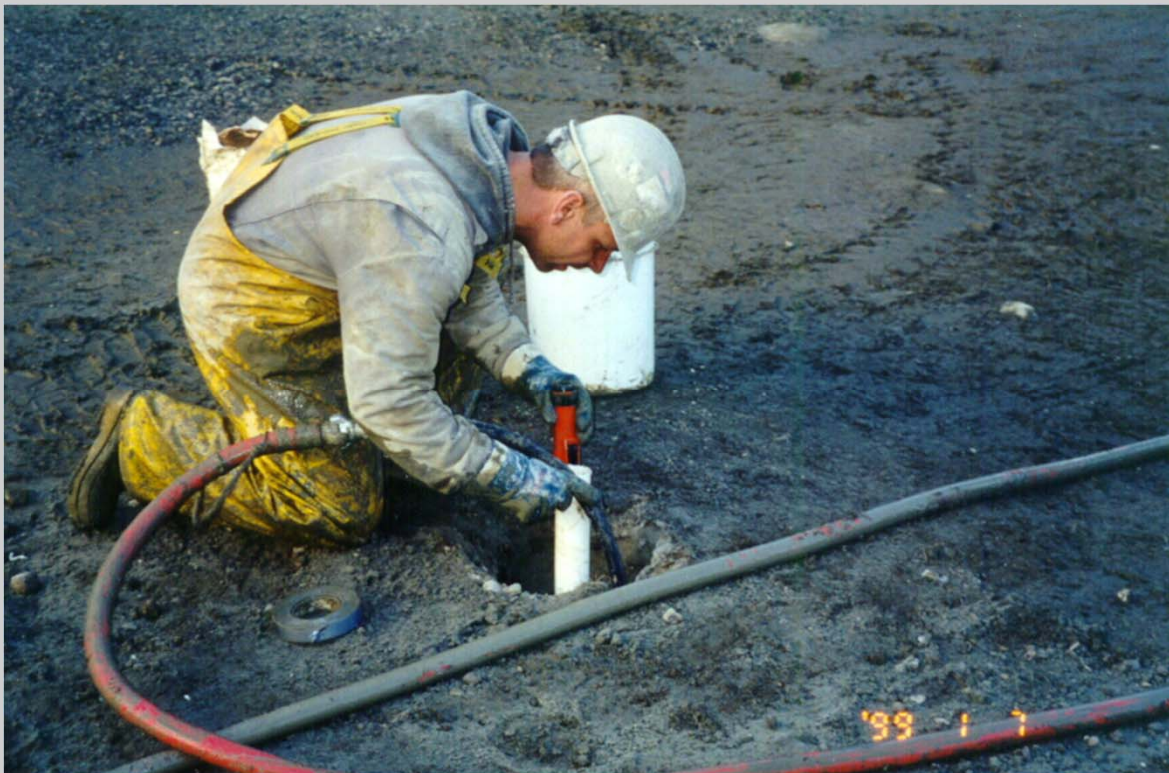
- *SHA was involve in the design of a grout barrier system to prevent leachate from entering Lynn Creek.*
- *The toe berm at the landfill was not effective and so a series of concrete grouted boreholes were placed in order to seal the toe berm from further leachate seepage allowing the leachate to be channeled to the leachate collector.*
