Case History ENVIRONMENTAL MONITORING

North Ravine Fire Suppression Program - Campbell Mountain Landfill, Regional District of Okanagan Similkameen

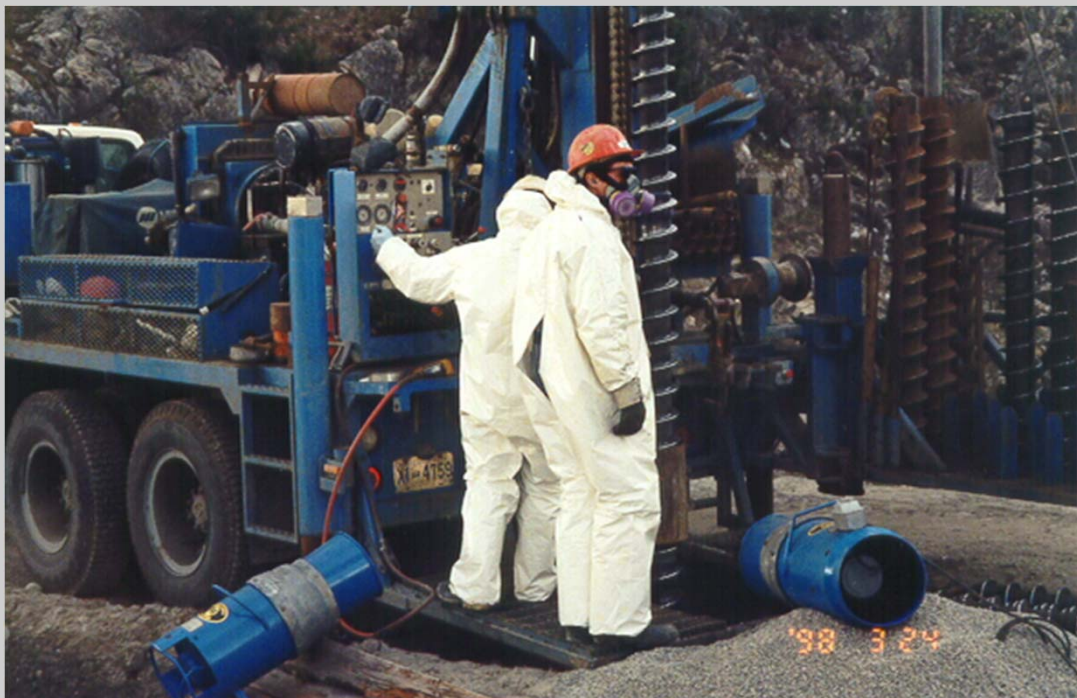
- *Fire was suspected in the North Ravine based on historical information.*
- *Initial investigation using bar punch survey detected elevated concentrations of carbon monoxide indicating oxygen starved combustion (subsurface fire).*
- *An auger rig was used to drill and install steel monitoring wells, (emphasis was placed on health and safety measures).*
- *Thermistor strings were installed in each well to measure temperature at various depths within the landfill.*
- *A clay cover system and shot-crete edge seal was installed to suppress the combustion.*
